STEEL BRIDGES

PRAGUE 2024

Remaining Fatigue Strength of an Orthotropic Steel Deck with Respect to a Repair Method by Cold Joining Techniques

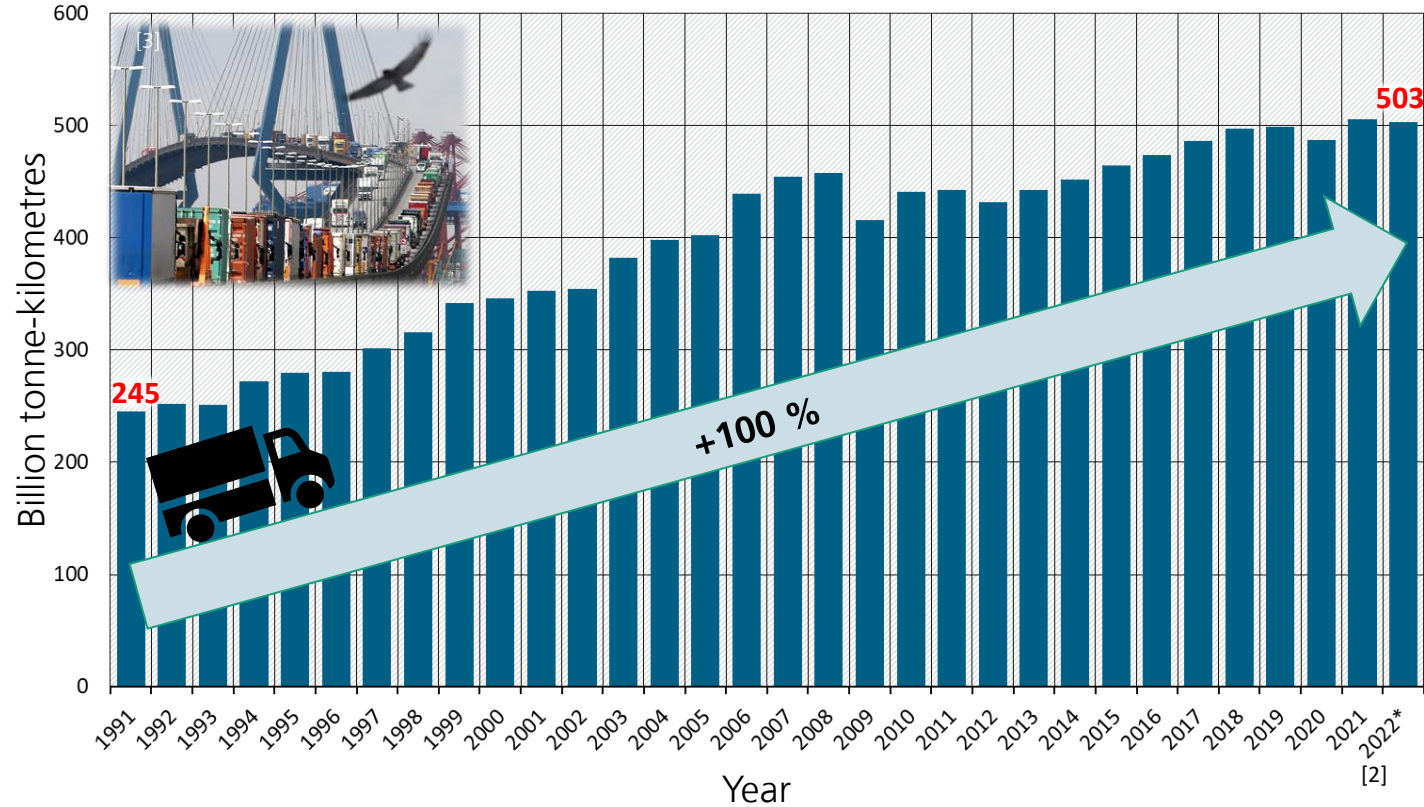
Freight transport performance in Germany

- Significant increase in size and weight of freight transport performance per vehicle
- Significant increase in freight transport performance
- Overuse of infrastructure that was not taken into account in the planning phase

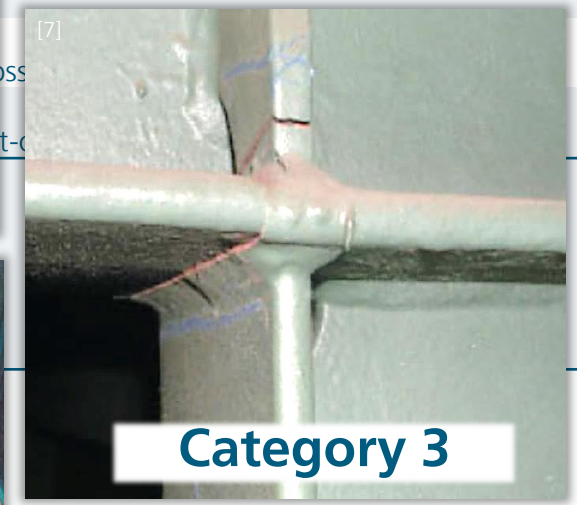
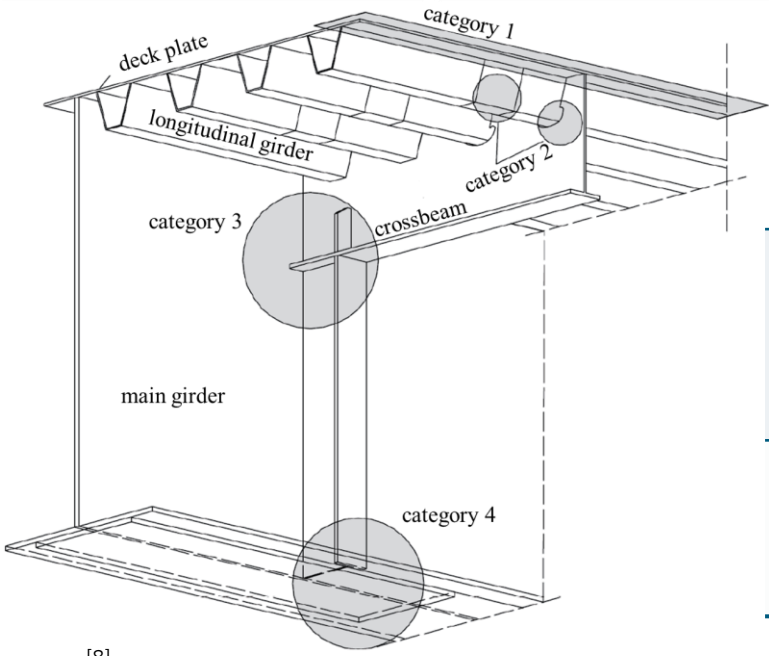
Category 1 Category 2a

Category 2b Category 2c

Category 3

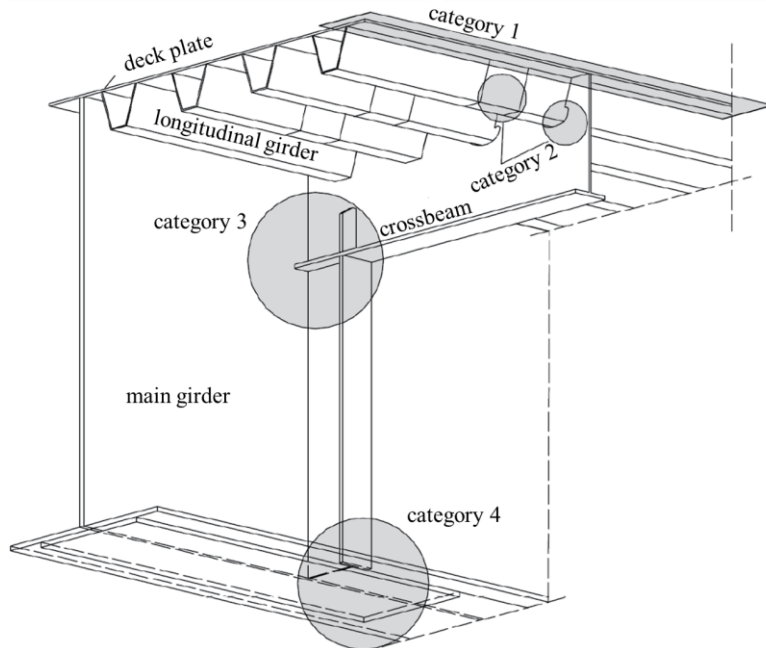
Damage category	Detail and Damage Tolerance
Category 1	Cover plate of deck slab <ul style="list-style-type: none"> • Redundancy available • Multiple load paths exist
Category 2	Connections between crossbeam and discontinuous longitudinal girder or splice between continuous longitudinal girder <p>Category 2a</p> <ul style="list-style-type: none"> • Fatigue failure of splice between longitudinal girder <p>Category 2b</p> <ul style="list-style-type: none"> • Fatigue failure of discontinuous longitudinal girder to crossbeam joint <p>Category 2c</p> <ul style="list-style-type: none"> • Fatigue failure of crossbeam at free edge of extended cut-out
Category 3	Components and connections in the crossbeam <ul style="list-style-type: none"> • Redundancy available to a limited extent • Secondary damages very likely • Component failure possible • Multiple load paths available to a limited extent • Local collapse of the structure

Category 4	Main structure and girder. <ul style="list-style-type: none"> • No redundancy available • Secondary damages likely • Single load paths • Global collapse of the structure

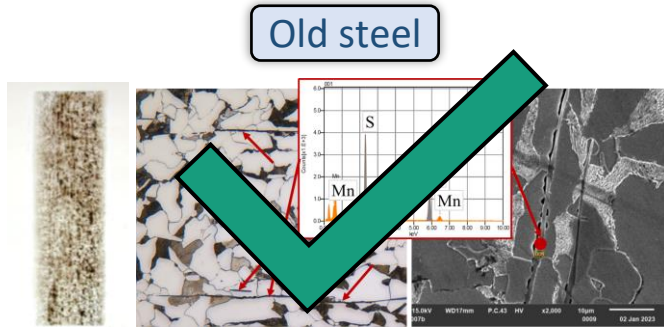
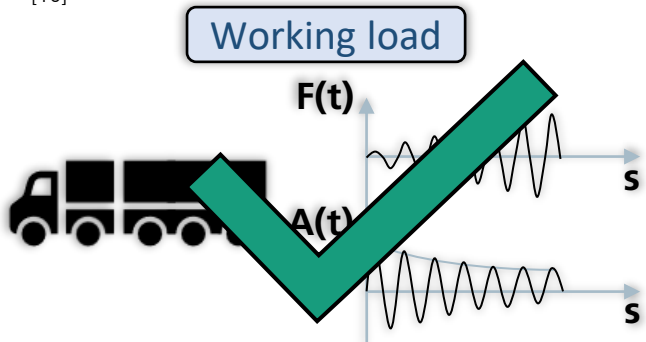
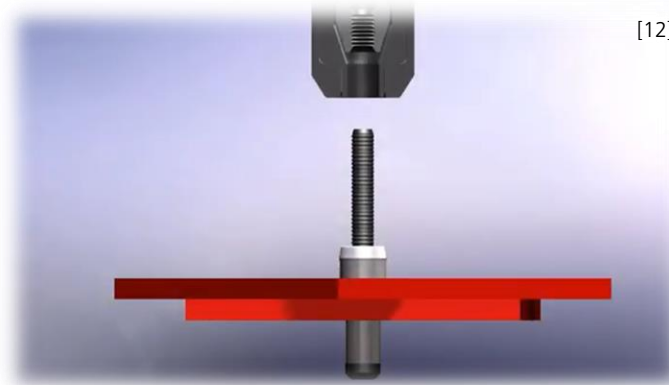
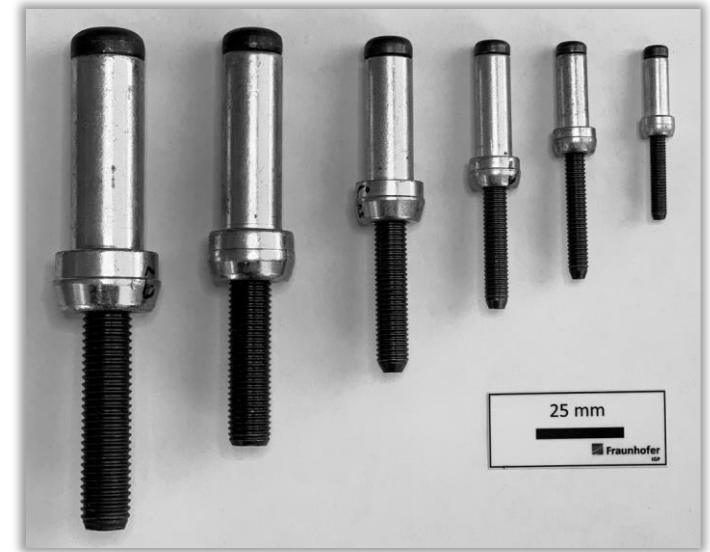
Cold joining technology

- No special preparation of the joint
- Easy installation of the blind fastener
- Only one-side accessibility is required
- \varnothing -range from 6.4 mm - 19.5 mm
- No thermal load shrinkage stress

Application of blind fastener

- ! Missing design rules acc. to Eurocode 3
- ! Application by individual case studies
- ! National Technical Approval | General Construction Technique Permit | European Technical Assessment
- Close gap of knowledge by systematic investigations

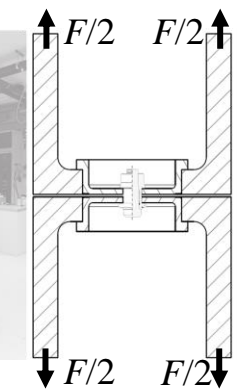
series	d [mm]	parameter I	parameter II		$d_{0,min}$	$d_{0,max}$
		l_k [mm]	$t_1 < t_{II}$ [mm]	$t_1 > t_{II}$ [mm]		
01	6.4	4.0 – 18.2	2.0 + 5.1	5.1 + 2.0	7.1	7.4
02	7.8	4.8 – 27.0	2.5 + 8.6	8.6 + 2.5	8.9	9.3
03	9.5	8.0 – 30.1	3.0 + 24.0	24.0 + 3.0	10.5	11.0
04	12.7	9.6 – 41.2	4.0 + 34.2	34.2 + 4.0	13.9	14.7
05	15.9	12.8 – 21.6	5.0 + 20.6	20.6 + 5.0	17.5	18.4
06	19.1	12.8 – 31.6	6.0 + 19.6	19.6 + 6.0	21.1	22.1

1) Configuration for tension tests

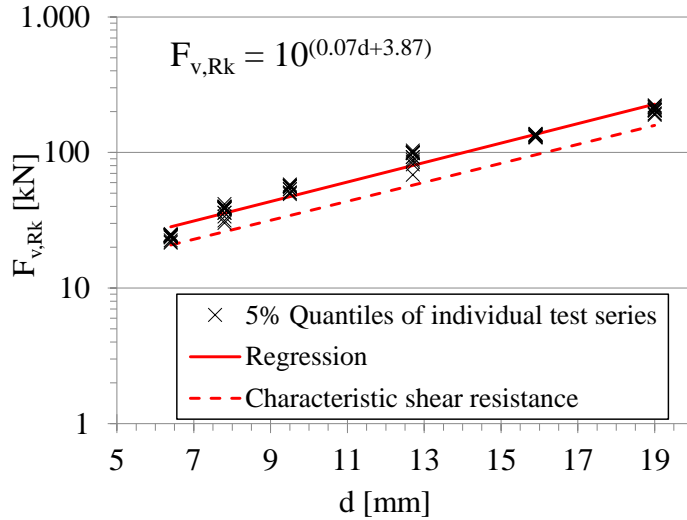
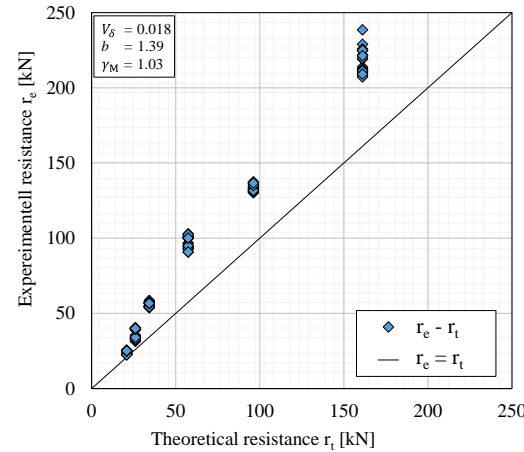
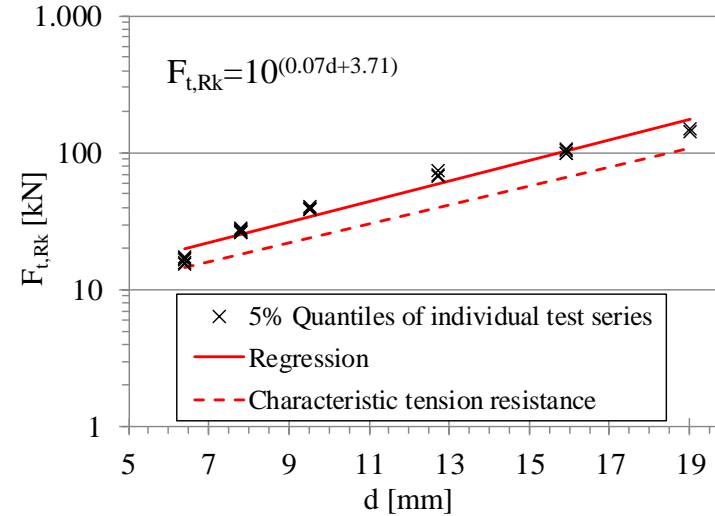
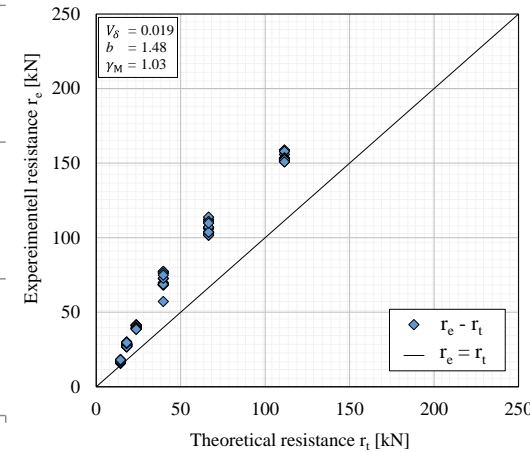
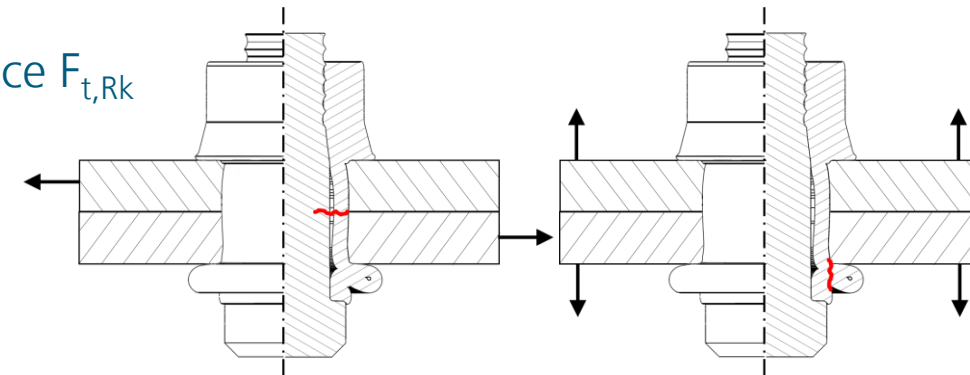
Results:

- Design equation for the characteristic shear $F_{v,Rk}$ and tension resistance $F_{t,Rk}$
- Statistical evaluation acc. to EN 1990 Annex D
 - Comparison of experimental and theoretical results
 - Partial factor γ_M below $\gamma_{M2} = 1.25$ (resistance of fasteners)

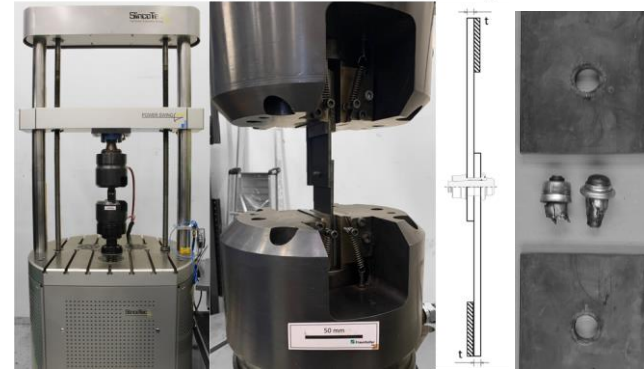
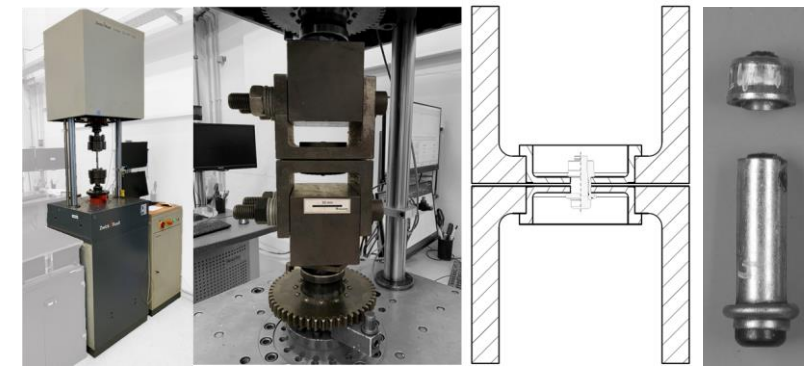
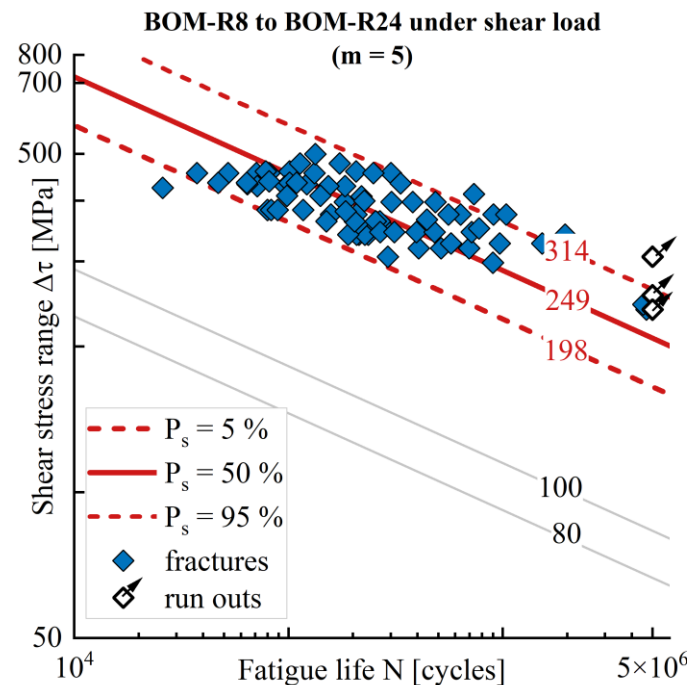
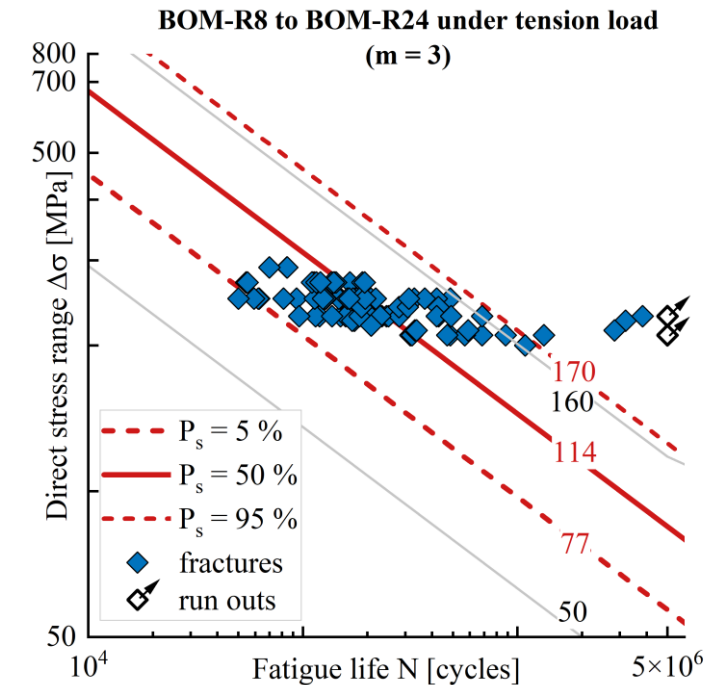
Test procedure:

- Load level method
- Load ratio $R = 0.1$
- Test frequency $f = 41 - 89$ Hz
- End of test – run-out ($N_D = 5 \cdot 10^6$) or fracture of specimen
- Evaluation acc. to BACKGROUND INFORMATION OF FATIGUE DESIGN RULES

Results:

- Characteristic shear stress range $\Delta\tau_C = 198$ N/mm² (m=5)
- Characteristic direct stress range $\Delta\sigma_C = 77$ N/mm² (m=3)

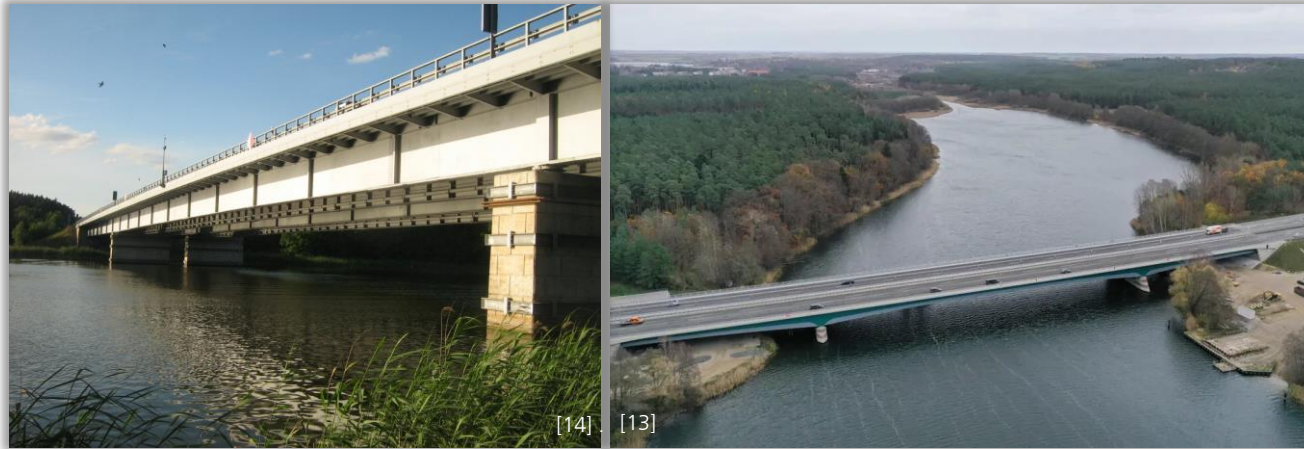
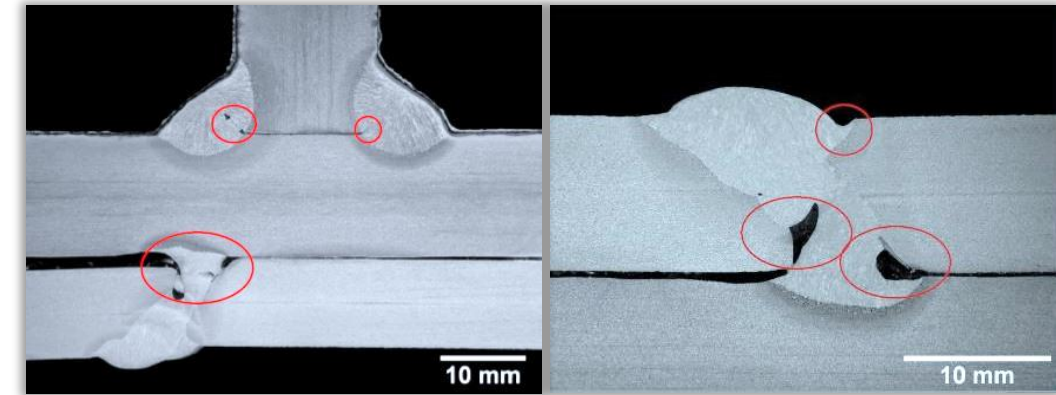
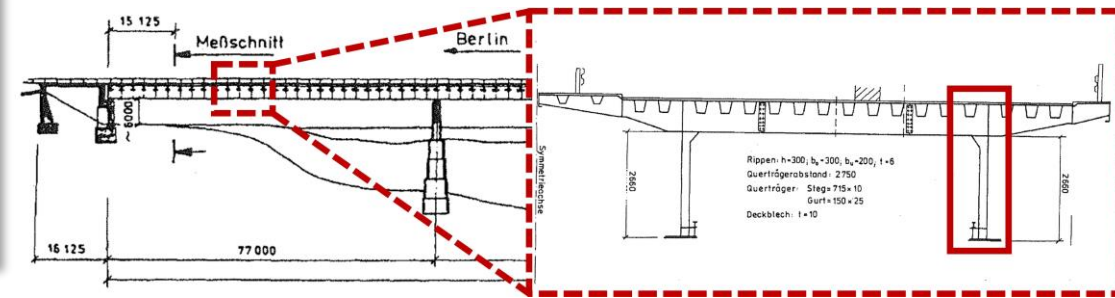
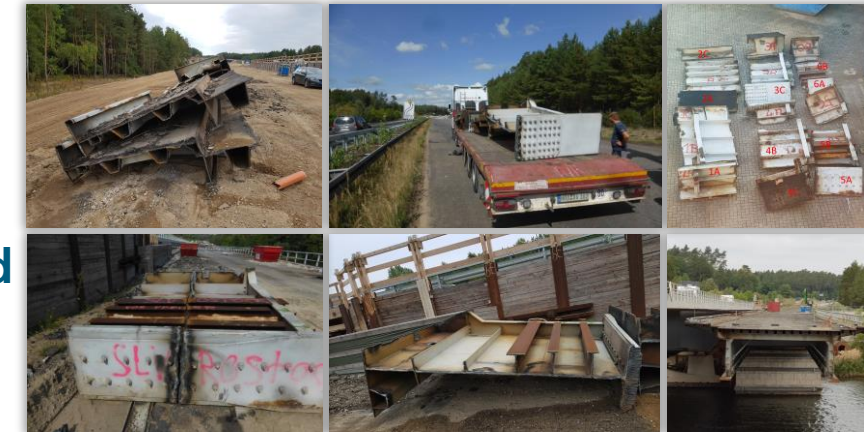
Old steel from demolished bridge structure

Repair method by welding:

- **Repairing in main girder** area with additional plates
- Webs of the main girder subjected to **tensile stresses from welding**
- Old material failed by lamellar tearing → **Manganese sulphides** in the material was found as reason
- lack of stability of the old bridge and **problems with the repair method**

Demolished steel bridge:

- Provision of **test material from middle section** for fatigue tests

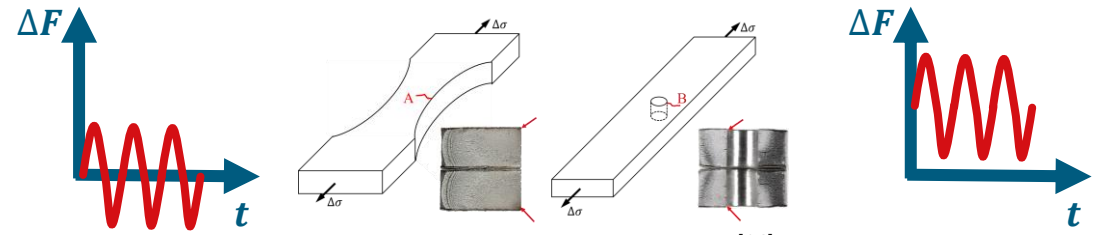
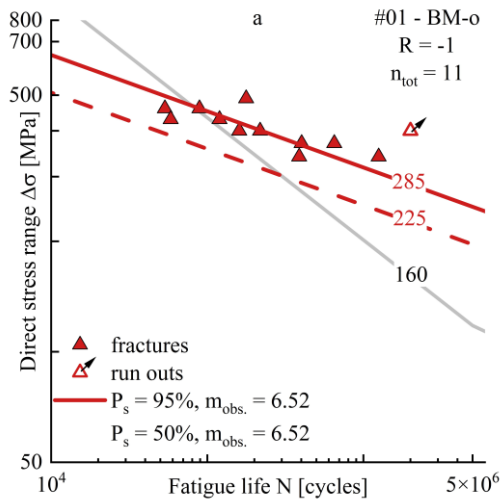
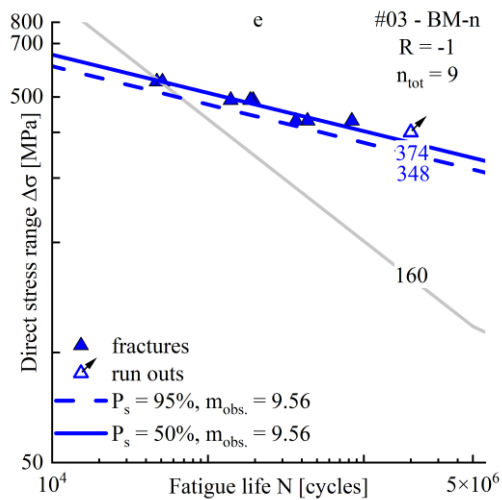
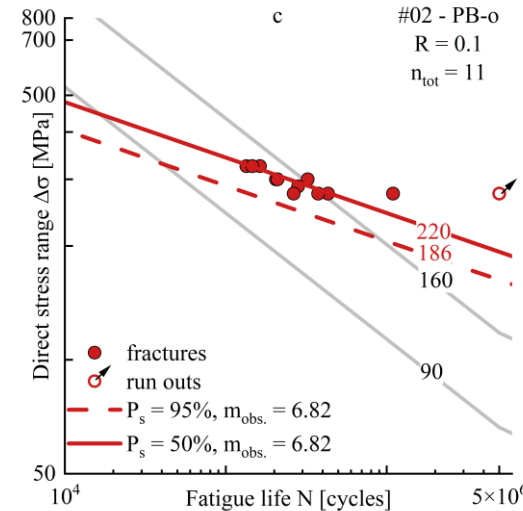
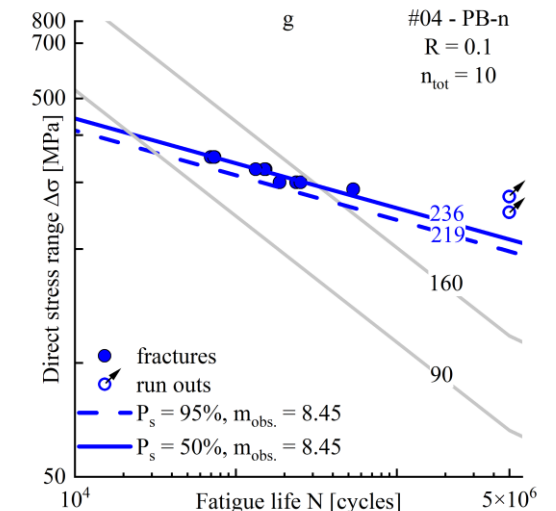
Fatigue tests on base material and perforated bar

Test procedure:

- Load level method
- Load ratio $R = -1$ (BM) | 0.1 (PB)
- Test frequency $f = 8 - 20$ Hz (BM) | $93 - 93$ Hz (PB)
- End of test – run-out [$N_D = 2 \cdot 10^6$ (BM) | $N_D = 5 \cdot 10^6$ (PB)] or fracture of specimen
- Evaluation acc. to BACKGROUND INFORMATION OF FATIGUE DESIGN RULES

Results:

- Lower fatigue resistance of base material
- Comparable fatigue resistance of perforated bars
- Surface condition dominates the fatigue resistance of base material
- Notch effect dominates the fatigue resistance of perforated bars
- No pre-damage to the base material due to the service lifetime
- Repair solution with cold joining technology is like a new joint

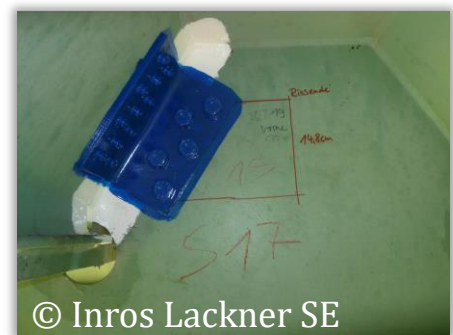
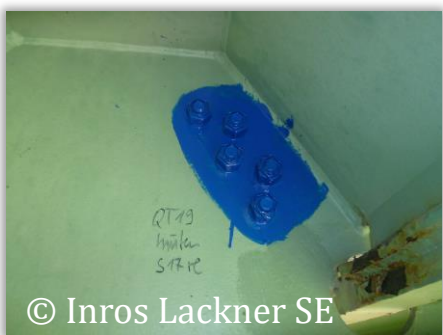
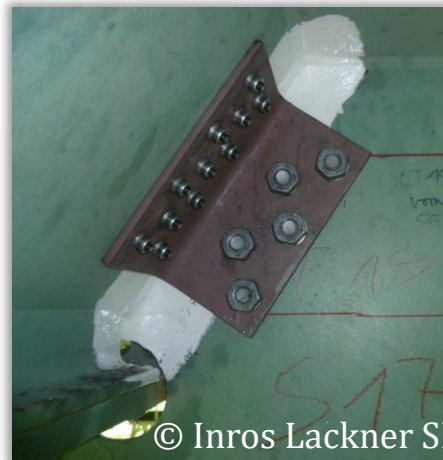
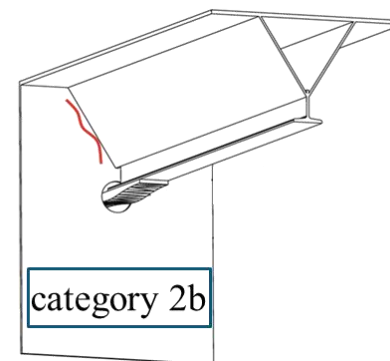
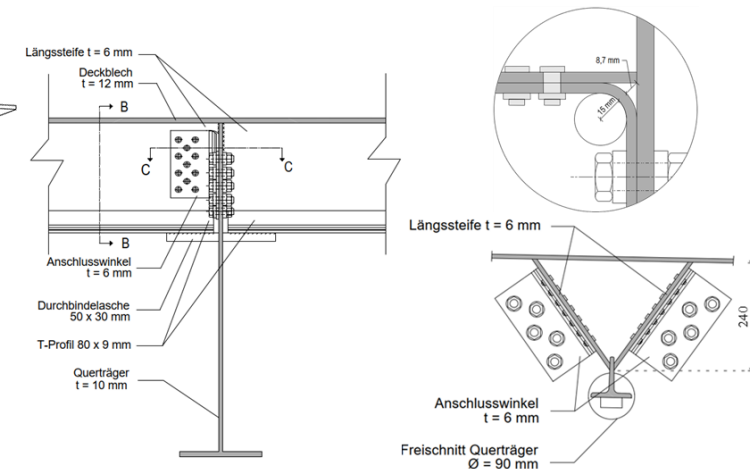
Cold Joining Technology

- Removal of coating and application of brittle lacquer
- Adapted bracket
- Hole manufacturing with magnetic drilling machine
- Provisional bolting of the bracket by 8 mm bolts with the crossbeam
- Alignment of the bracket for full contact between bracket and crossbeam as well as longitudinal stiffener
- Manufacturing of the holes in the longitudinal girder by reaming from 9.5 mm to 10.5 mm in the bracket and drilled through the girder
- Installation process of BOM-R12-8 from inside to outside - alternately
- Same procedure for connection between crossbeam and bracket with fit bolts according to EN 14399-8, strength grade 10.9, galvanised and bring to snug-tight condition
- Application of corrosion protection
